Mosaics In Situ Project

ILLUSTRATED GLOSSARY

Definitions of terms used for
the graphic documentation of in situ floor mosaics

Developed by the Getty Conservation Institute and
the Israel Antiquities Authority

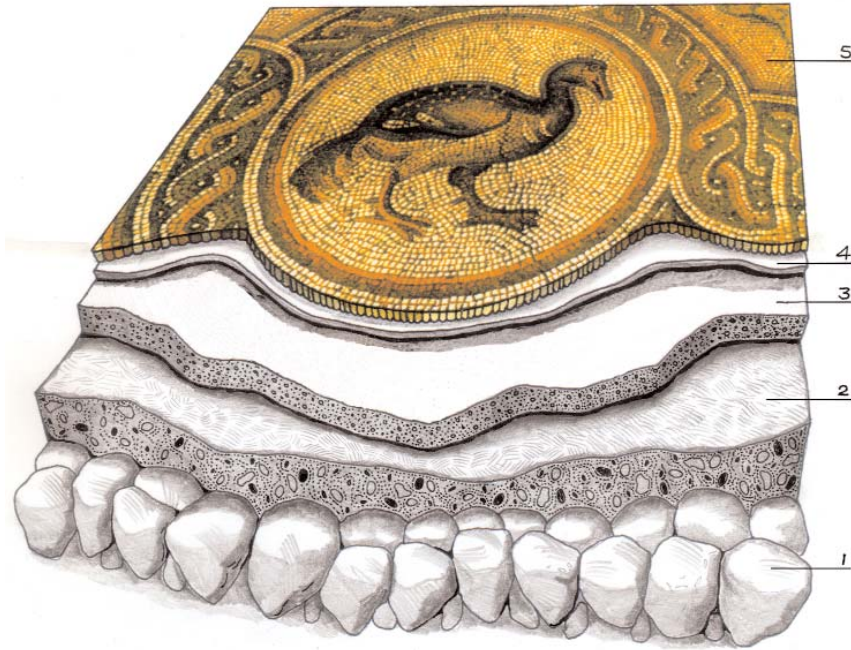
MOSAIC STRATIGRAPHY

The following stratigraphy is adapted from ancient literary sources. It is to be used only as a general reference in this document. In practice, all mosaics do not necessarily display this stratigraphy.

A mosaic can be built on natural ground made of soil or rock, or on top of a previous pavement. The mosaic itself is composed of a variety of foundation or preparatory layers and a layer of tesserae.

1 - Statumen - First preparatory layer which is made of large stones laid on the ground, previously leveled and rammed. This layer only exists if the mosaic has been constructed on a natural soil.

2 - Rudus - Second preparatory layer which is spread over the statumen. This layer is made of a lime mortar with large aggregates.

3 - Nucleus - Third preparatory layer which is spread over the rudus in a thinner layer. The nucleus is made of a mortar with fine aggregates.

4 - Bedding layer - Fourth preparatory layer of mortar which is very rich in lime, and thinly applied in small sections over the nucleus. Tesserae are inserted in this layer before the mortar sets.

5 - Tessellatum - Layer which constitutes the mosaic surface and is composed of tesserae and mortar filling the interstices between them.

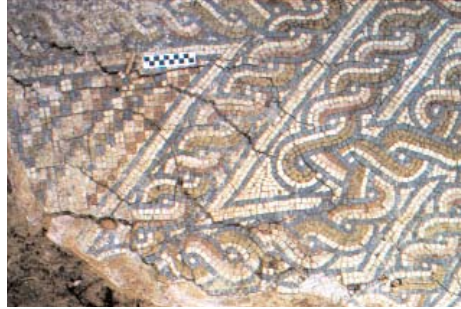
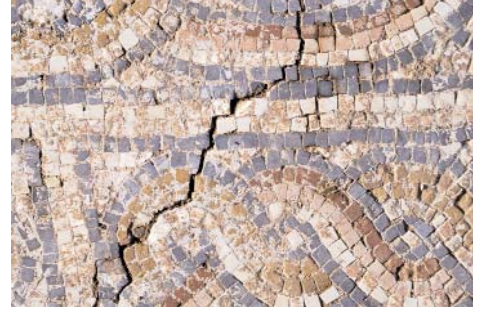
CRACK

Linear breaks visible at the surface of the mosaic, which may also penetrate into its lower layers.

The word fracture is also commonly used to describe this condition.

Crack

Left photo: Horvat Minnim, Israel. Mosaic no.1. September 1998. Frank Long © J. Paul Getty Trust

Right photo: Horvat Minnim, Israel. Mosaic no.4. September 1998. Frank Long © J. Paul Getty Trust

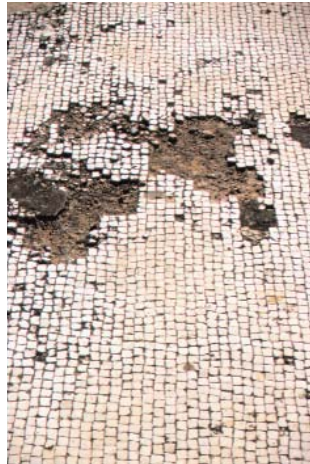
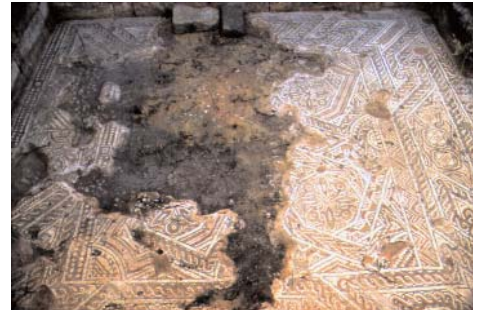
LACUNA

Area of the mosaic where the tessellatum is missing.

Within a single mosaic, lacunae can be classified according to their depth; for example lacuna of tessellatum, bedding layer or nucleus.

The word loss is also commonly used to describe this condition.

Lacuna

Left photo: Utica, Tunisia. Maison des Chapiteaux Historiés, room V. November 2001. Elsa Bourguignon © J. Paul Getty Trust

Right photo: Horvat Minnim, Israel. Mosaic no.1, west side. September 1998. Frank Long © J. Paul Getty Trust

Top drawing: Drawing by Bettina Lucherini © J. Paul Getty Trust

Bottom drawing: Drawing by Haim Kapschitz © Israel Antiquity Authority

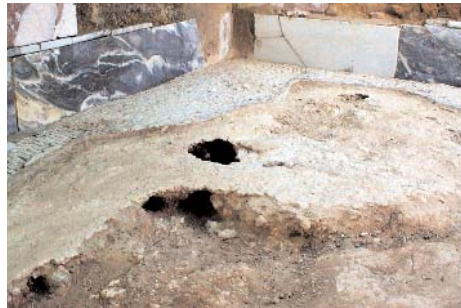
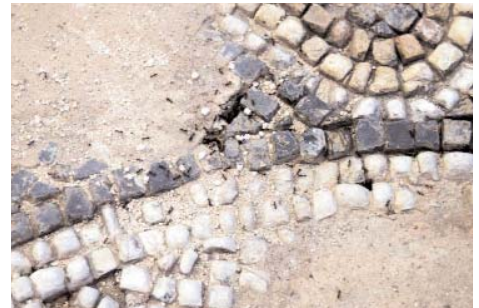
CAVITY

Area of sub-surface loss.

Cavities can be due to water erosion or animals, including insects, burrowing.

Cavity

Left photo: Utica, Tunisia. 2001. Bettina Lucherini © J. Paul Getty Trust

Right photo: Thuburbo Majus, Tunisia. Maison de Neptune, peristyle. June 2002. Thomas Roby © J. Paul Getty Trust

Bottom drawing: Drawing by Haim Kapschitz, modified by Elsa Bourguignon © J. Paul Getty Trust

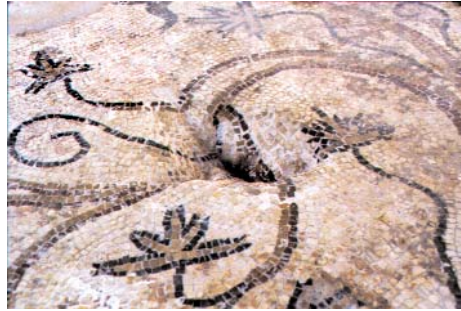
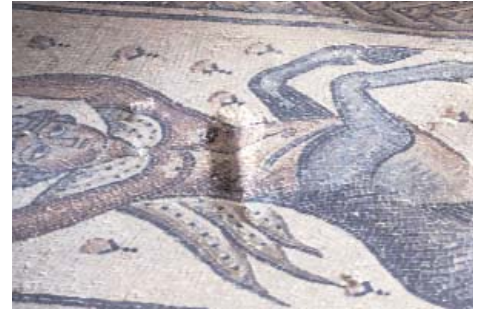
DEPRESSION

Downward deformation of the mosaic below its original surface level.

Depression

Left photo: Caesarea, Israel. November 1999. Francesca Piqué © J. Paul Getty Trust

Right photo: Zippori, Israel. Mosaic of the Nile. 1998. Francesca Piqué © J. Paul Getty Trust

Bottom drawing: Drawing by Haim Kapschitz © Israel Antiquity Authority

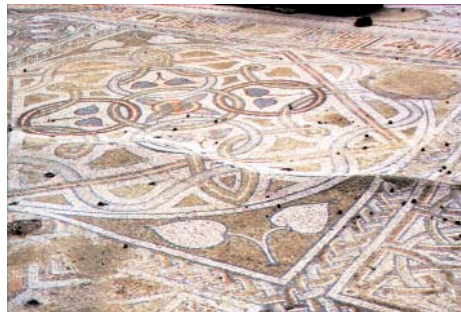
RISE / BULGE

Upward deformation of the mosaic above its original surface level.

Rise / Bulge

Left photo: Beth Shean, Israel. November 1999. Francesca Piqué © J. Paul Getty Trust

Right drawing: Drawing by Haim Kapschitz © Israel Antiquity Authority

Bottom drawing: Drawing by Haim Kapschitz © Israel Antiquity Authority

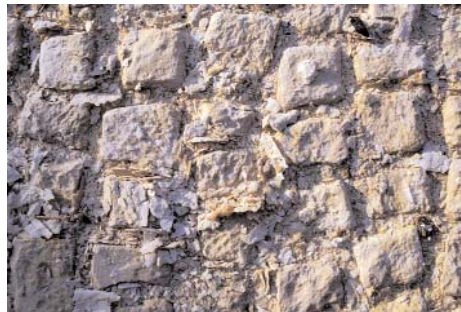
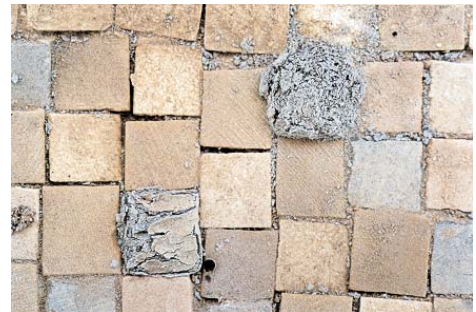
DISAGGREGATED TESSERAE

Tesserae displaying loss of cohesion of their surfaces, which have disintegrated into powder or small grains.

Disaggregated tesserae

Left photo: Caesarea, Israel. November 1999. Francesca Piqué © J. Paul Getty Trust

Right photo: Caesarea, Israel. Francesca Piqué. © J. Paul Getty Trust

Bottom drawing: Drawing by Bettina Lucherini © J. Paul Getty Trust

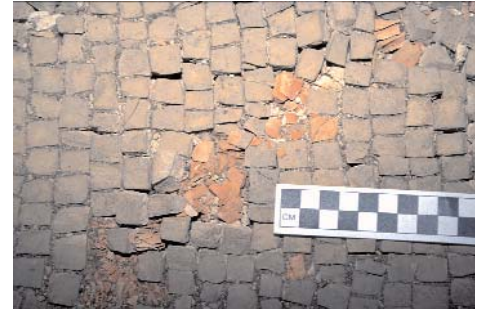
EXFOLIATED TESSERAE

Tesserae displaying detachment or loss of layers, parallel or perpendicular to the mosaic surface.

Exfoliated tesserae

Left photo: Caesarea, Israel. November 1999. Francesca Piqué © J. P. Getty Trust

Right photo: Beth Shean, Israel. Kyria Maria monastery, northwest corner of mosaic, west of large mosaic. August 1997. Francesca Piqué © J. Paul Getty Trust

Bottom drawing: Drawing by Haim Kapschitz © Israel Antiquity Authority

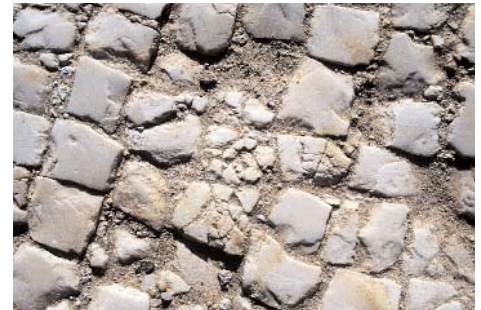
FRACTURED TESSERAE

Tesserae displaying linear breaks or network of breaks through their matrix.

Fractured tesserae

Left photo: Paphos, Cyprus. June 2002. Elsa Bourguignon © J. Paul Getty Trust

Right photo: Caesarea, Israel. April 1999. Cynthia Godlewski © J. Paul Getty Trust

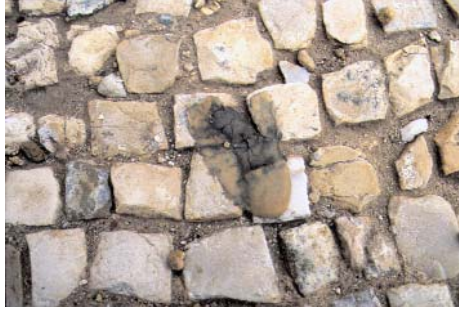
DEPOSIT

Accumulation of extraneous material of various types, such as soil, sand, animal droppings and vegetal materials, of variable thickness, and poor adhesion to the mosaic surface.

Deposit

Left photo: Caesarea, Israel. April 1999. Cynthia Godlewski © J. Paul Getty Trust

Right photo: Beth Shean, Israel. Kyria Maria. May 2000. Gaetano Palumbo © J. Paul Getty Trust

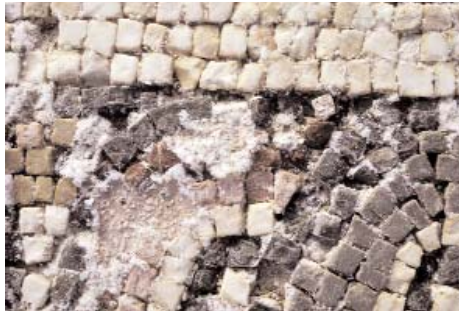
EFFLORESCENCE

Formation at the mosaic surface of a loosely adhering substance, generally white and crystalline, powder-like or whisker-like in appearance.

Efflorescence

Left photo: Paphos, Cyprus. Birth of Achilles mosaic. January 1999. Francesca Piqué © J. Paul Getty Trust

Right photo: Paphos, Cyprus. Birth of Achilles mosaic. January 1999. Francesca Piqué © J. Paul Getty Trust

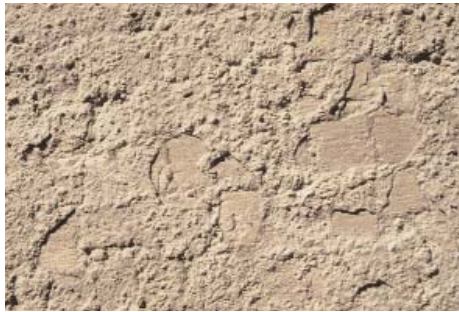
INCRUSTATION

Mineral crust formation adhering to the mosaic surface, often hard and compact, and of variable thickness and extent.

Incrustation

Left photo: Paphos, Cyprus. January 1999. Francesca Piqué © J. Paul Getty Trust

Right photo: Beth Shean, Israel. Tel Iztaba. May 2000. Gaetano Palumbo © J. Paul Getty Trust
